# Kidde Recalls Dual Sensor Smoke Alarm Due to Potential Safety Risk

**Brand Name, Model of Affected Product:** Kidde Dual Sensor (Photoelectric and Ionization) Smoke Alarms – Models PI2010 and PI9010

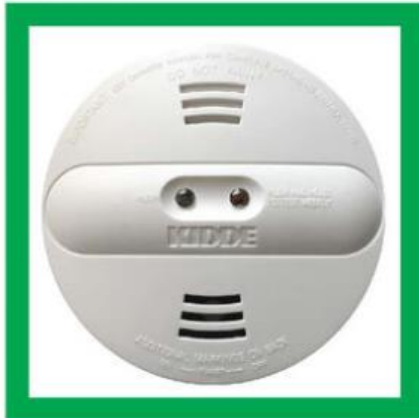
### Affected

Compare your alarm model to other smoke alarm models. Affected units are identical to the alarm featured in the green box. All other smoke alarms are not affected by this product notice.

Look for this pill shaped design on the front of the unit. This feature is slightly raised and is unique to this alarm.

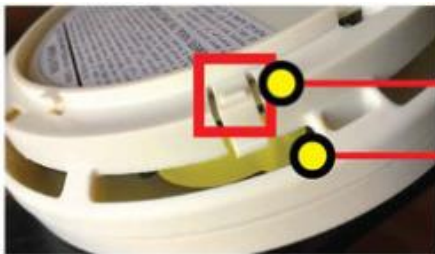
### Affected

Turn the alarm on its side and look at the opening closest to the locking tab. If a yellow cap can be seen in the opening the unit is affected and must be replaced.

Locking tab.

Yellow cap is visible, request a replacement immediately and reinstall until replacement arrives!

If your smoke alarm is affected, please register for a replacement at <https://kidde-smoke-alarm-recallusen.expertinquiry.com/vinylpage>

Do not attempt to take apart the alarm, open the casing, or remove the yellow cap. If a yellow cap is present, immediately contact Kidde. They can replace it with a properly functioning smoke alarm.

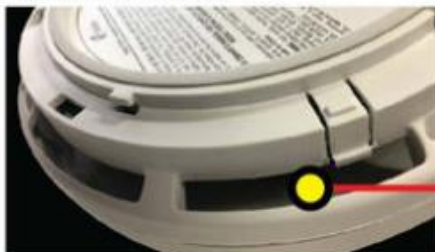
### Not Affected

No yellow cap is visible. Unit is not affected.
